Denial of Motor Vehicle Defect Petition

ACTION: Denial of a petition for a defect investigation.

Appendix - Petition Analysis - DP15-005

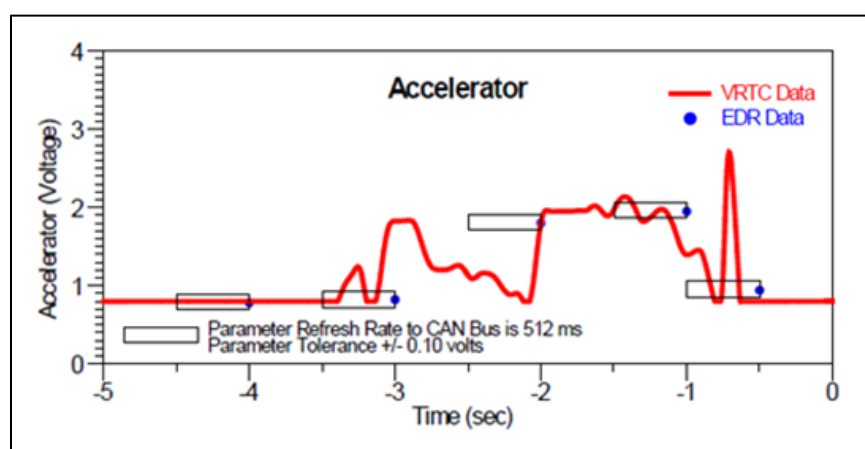
In 2010, NHTSA's Vehicle Research and Test Center (VRTC) conducted testing to validate the EDR pre-crash data used in NHTSA field investigations.⁴ Figure 1 shows accelerator pedal sensor voltage data from one test performed by VRTC in the validation testing.⁵ As the figure shows, the EDR does not necessarily capture all accelerator pedal applications during an event and the accelerator pedal voltage recorded at each EDR time interval may not be the actual accelerator pedal voltage at that interval.

Figure 1. VRTC validation testing of EDR accelerator pedal sensor voltage from simulated collisions in a 2007 Toyota Camry.

Finally, it is not accurate to state that engine speed increases did not result from accelerator pedal applications based strictly on the recorded EDR data, since the data do not necessarily show all accelerator pedal applications (see section 2.1 and Figure 1) and because of the differences in refresh rates for engine speed and accelerator rate. Although actual engine speed will closely follow accelerator rate, the recorded accelerator rate may slightly lag behind recorded engine speed due to the slower refresh rate of the accelerator signal (see Table 1).
